Manhole Inspection Summary

Manhole # S47E__048MH

Insp Date: **7/31/08 10:20 AM**

Location Address: **Patterson Park**

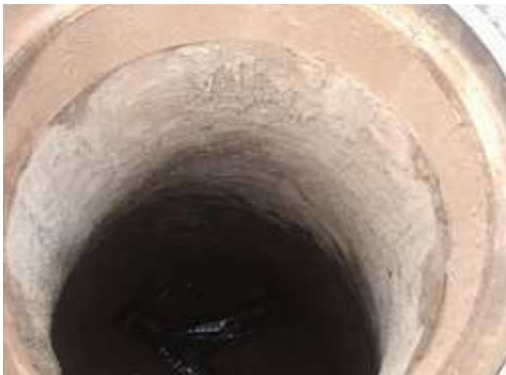
Defect 1

Infiltration: ☐ None ☐ Joint ☐ Cracks ☐ Mortar ☐ Roots ☒ **Wall**

infiltration

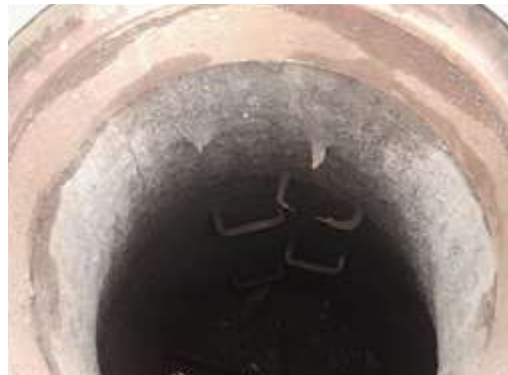
Defect 2

☒ **Leaks**

frame leaks

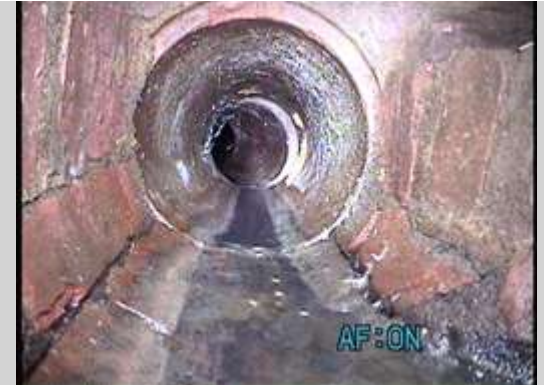
12 O'Clock Outflow

Pipe Height: **8.4** (in.) Rod and Bar (Angled)
Pipe Material: **Clay** ☐ Pipe Lined
Invert Depth: **9.90** (ft.) Flow Characteristics: **Fast**
Deposits: ☒ None ☐ Mud ☐ Sludge ☐ Debris ☐ Grease
Silt Depth: (in.) Deposits Extent:
Infiltration: **None** Pipe Seal Cond: **Sound**

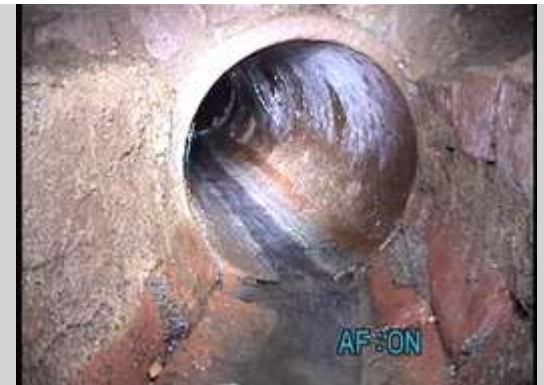
3 O'Clock Inflow

Pipe Height: **8.4** (in.) Rod and Bar (Angled)
Pipe Material: **Clay** ☐ Pipe Lined
Invert Depth: **9.85** (ft.) Flow Characteristics: **Fast**
Deposits: ☒ None ☐ Mud ☐ Sludge ☐ Debris ☐ Grease
Silt Depth: (in.) Deposits Extent:
Infiltration: **None** Pipe Seal Cond: **Sound**

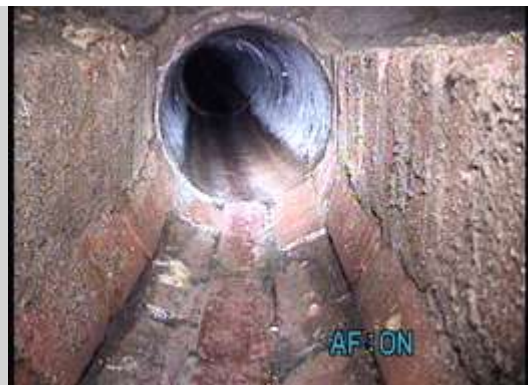
6 O'Clock Inflow

Infiltration: **None** Pipe Seal Cond: **Sound**
